# **A Review of Environmental Incidents at Anaerobic Digestion (AD) Plants and Associated Sites between 2010 and 2018**

September 2019

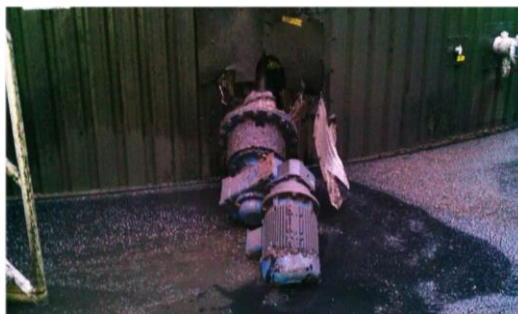
Complete loss of digester tank contents to ground. The site had been built without full planning permission or a permit and the site was discovered after the pollution incident.

The digester mechanical stirrer fixings failed causing a hole in the concrete digestate tank. Secondary containment not in place.

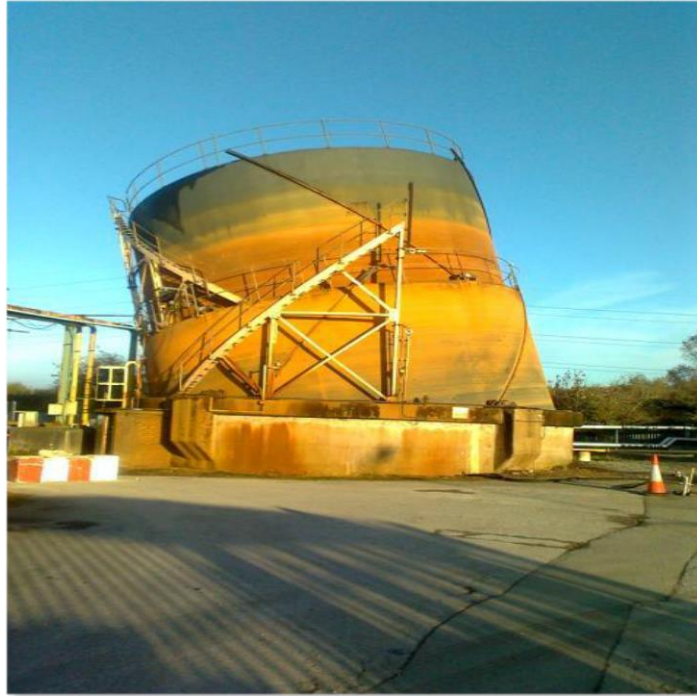
## October/November 2011 – Wastewater Treatment Works

An estimated 50,000M3 of biogas was lost to the atmosphere over 19 days as a result of the catastrophic failure (collapse) of the gas holder and the subsequent release of biogas via the pressure/vacuum release valves as a safety measure, between the above dates. The standby flare failed to operate and a temporary flare was not installed.

Three sets of guide wheels on the holder had disengaged, its limit switches had failed and sections of the guide rails were corroded. This led to the holder tilting dangerously and gas being released. The Fire Service had to be called because there was a risk of an explosion.

The Environment Agency estimated that the global warming potential of the incident was equivalent to 456.6 tonnes of CO<sub>2</sub>. The company was fined £400,000 for polluting the air with potentially explosive biogas.

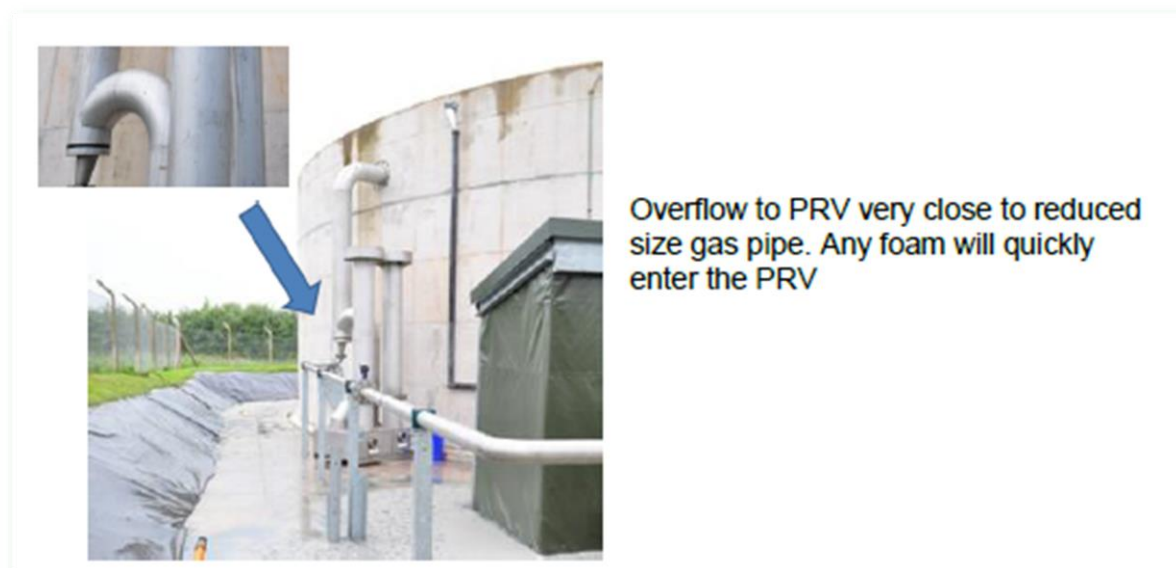
The pressure release system was found to be blocked by foam. Foam is a common occurrence and can be formed by a number of different factors including overloading, presence of detergents and high nitrogen content feedstocks.

The digester was fitted with a water spray to knock down any foam but this was found to have been turned off. There was no foam sensor system and the design of the gas pipework did not protect the pressure release valve from foam carryover. Human error and a management system failure was the root cause of the incident. Very little thought was given to the effects of foaming on the PRV and there was no critical alarm on the gas flow to the CHP.

The pipework was changed to protect the pressure release valve. Foam sensors were added to the catch pot.

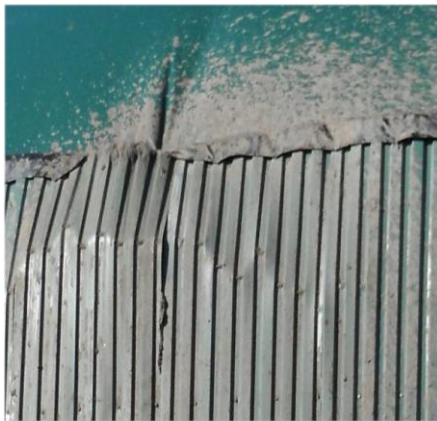
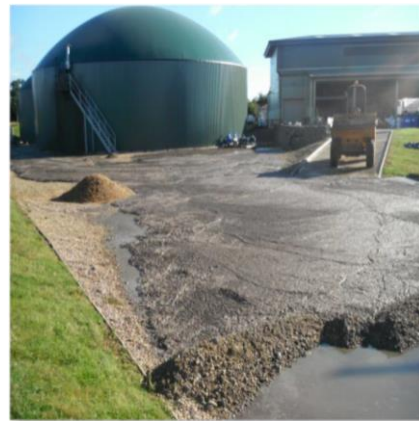
### September 2012 – Merchant Facility

The membrane roof and steel sides of the digester were damaged due to foaming. The clean-up operation was extensive. Biogas was lost to atmosphere whilst the digestate was contained within the bund. The bunded area was graveled which made clean up difficult.

The pressure release system was found to be blocked by foam. In this case the excessive foam was caused by overfeeding the reactor i.e. operator error. The design of the digester did not cope with the amount of foam. Fully trained and competent employees were not operating the plant at the time of the incident which meant VFA levels were not being monitored and led to over-feeding.

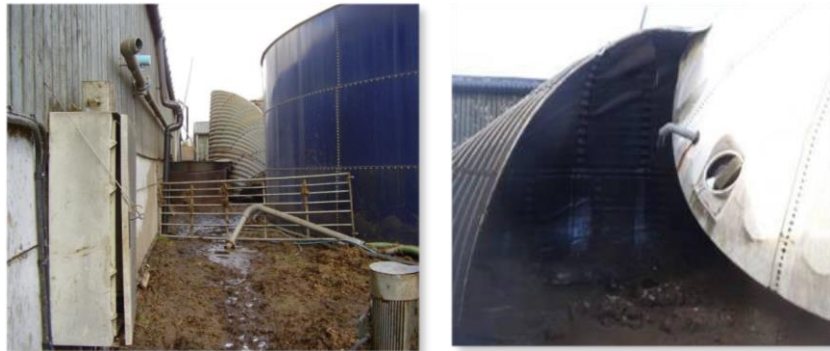
A 330 cubic meter glass fused steel digester tank violently burst open under pressure (luckily whilst the site was unattended). Biogas was lost to atmosphere and digestate lost to ground.

The inclusion of partially chopped/ macerated straw in a slurry feedstock with a low total solids percentage, especially in wet weather, led to a floating layer of material on the liquid in the tank. This may have disabled the correct operation of the float switch because it had to be inverted by its own buoyancy to operate. This meant the tank may have been overfilled by the feed pump. The floating layer would have obstructed the tank roof pressure relief valves, allowing hydraulic pressure to build within the tank. The topography provided secondary containment however this may not have coped if the digester storage tank had gone as well.

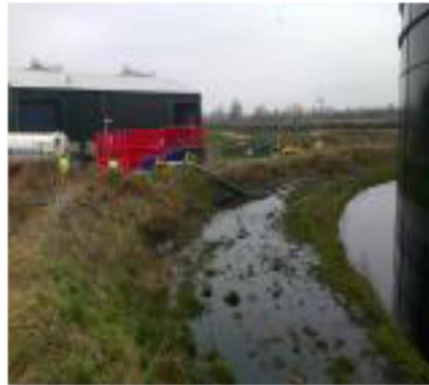
## February 2013 – Agricultural Facility

At least 750,000 gallons of digested slurry escaped from an above-ground digestate holding tank and retaining bund.

It appeared that the loss of containment had been due to a separation of the inner surface of the tank wall from the tank base and a loss of integrity of the mastic sealant between the two. Once the seal between the tank wall and the base lost its integrity there was a direct path for the digestate to leak to the outside. Once the inner contents had escaped the secondary containment feature i.e. the earth bund, failed to hold.

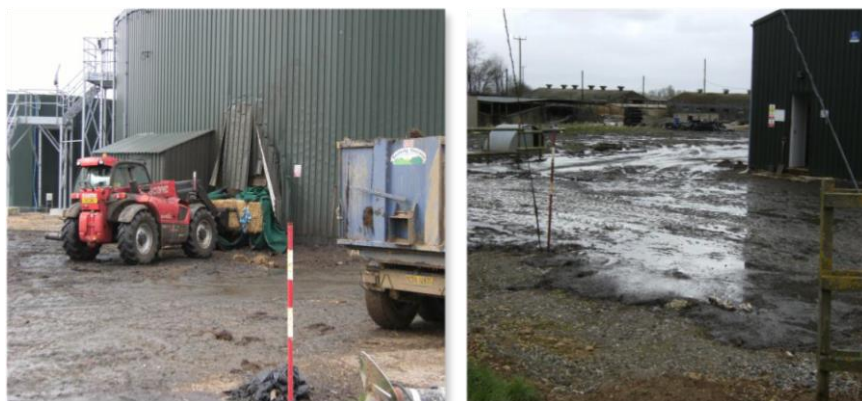
## March 2013 - Agricultural Facility Extended to Accept Pasteurised Food Waste

A large quantity of digestate escaped from a 3000m<sup>3</sup> digestion tank, with an estimated 200 to 400m<sup>3</sup> entering nearby ditches.

The seal around the agitator arm at the bottom of the tank failed, bolts were loose and the agitator was moving and making noise for several days. The partial secondary containment system was not a purpose built system. The majority of drainage from around the AD area flowed to the intensive pig farm, which had a drainage system leading to a series of storage lagoons. If livestock had been in their housing at the time of the incident they would have been fatally impacted.

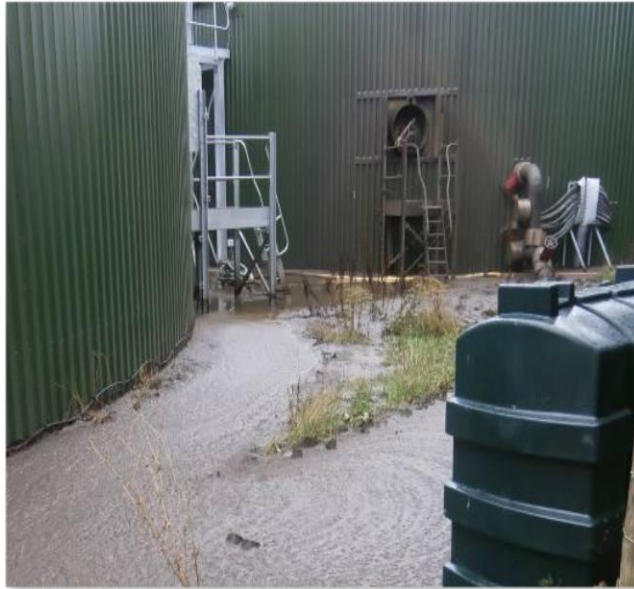
### September 2013 - Merchant Facility

Approximately 700 m<sup>3</sup> of its contents escaped from a digester. An unknown quantity of the digestate entered a beck, causing pollution of about 3.6 kilometers downstream. A faulty agitator had torn a hole in the side of the tank. There was no secondary containment for the digester.

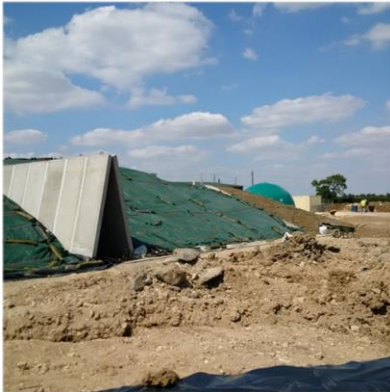
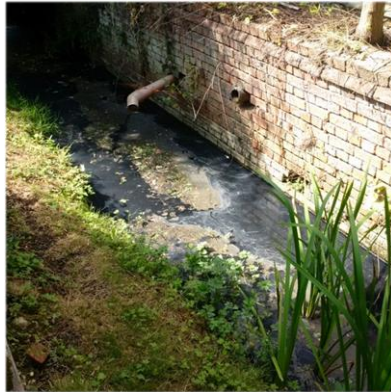
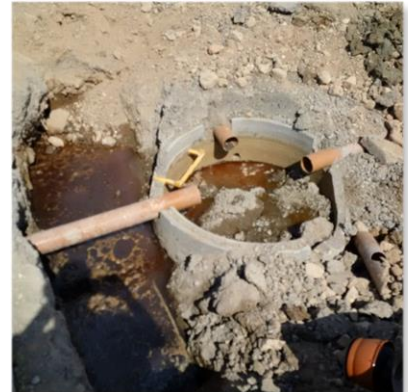
### August 2015 - Agricultural Facility (Non-Regulated)

Silage liquor escaped a silage clamp and drained into a nearby watercourse. The AD plant was not operational at the time however the silage clamps were storing feedstock.

Water pollution was spotted and reported to the local water company who investigated and found slurry in the land drain. Further investigation was done by the farmer who found a small leak on the silage pipe. The farmer was not sure when the leak started however the slurry tank was filled the previous month (July) and seemed to be running at that time. There was no indication of loss of flow. When the leak was discovered the farmer took immediate action by creating a sump to contain the slurry and prevent further pollution. He then emptied the slurry tank to prevent further impact.

Poor infrastructure was the main cause of incident. The effluent leaked through a join in the concrete, into the ground then to a land drain before discharging into the watercourse. About 1km of watercourse was impacted resulting in a category 2 incident.

- The land drain was blocked to stop the flow of effluent.
- The joint in the clamp was cut, cleaned and resealed.
- Additional pipes were installed around the clamp as a precaution to direct effluent to an underground storage tank.
- A vacuum tanker was purchased by the operator in case of future emergency.

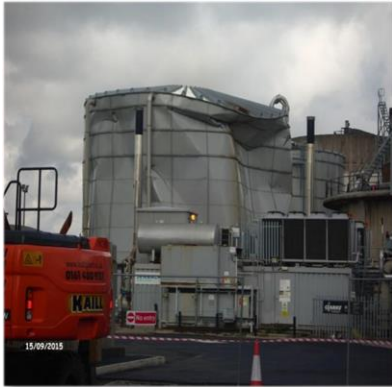
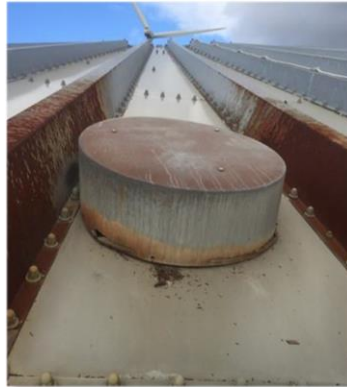
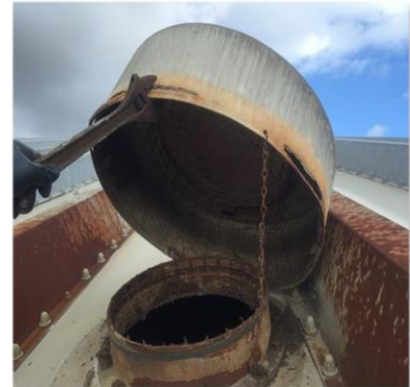
## September 2015 - Wastewater Treatment Works

A vacuum within a storage tank occurred leading to the tank buckling inwards. Fortunately there was no loss of containment.

The top hat PRV had rusted due to the acidic atmosphere and dropped down, creating a seal. When the odour control unit began operating a vacuum was formed in the screened sludge storage tank resulting in the tank walls, which were made of steel, being drawn in under vacuum and buckling.

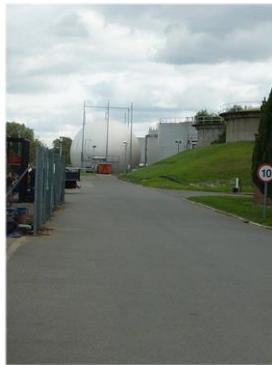
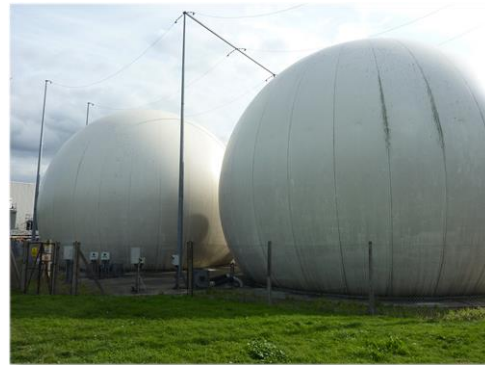
## September 2015 - Waste Water Treatment Works

A release of approximately 24,750m<sup>3</sup> biogas from pressure relief valves on 3 digester tanks occurred as a result of a failed (leaking) gas storage dome. Two storage domes were in situ on site but one was already out of service and had not been replaced/repared. The Environment Agency 'red-carded' the plant (i.e. did not visit because of potential H&S implications).

- Failing to identify and provide adequate contingency measures for the management of gas and sludge under abnormal operating conditions. Inadequate HAZOP assessment.
- Lack of maintenance and inspection and review of previous failures.
- Failing to react to indicators that the gas dome was failing. Continued feed to reactors resulting in diversion to PRV for gas management.
- Failing to follow procedures.
- Pipe-work connections meant there was no ability to by-pass the gas-domes and send the gas directly to the flare or CHP's resulting in direct release to atmosphere from PRV's.
- Pipe-work was mostly underground making inspection for further leaks difficult.

- Installation of temporary pipe-work to by-pass gas storage domes and enable gas flow to CHP & flare.
- Full root cause analysis undertaken.
- Full HAZID assessment.
- Replacement of gas storage domes.
- Review of procedures, in particular inspection & maintenance schedules and Accident Management Plan.
- Review of internal processes.

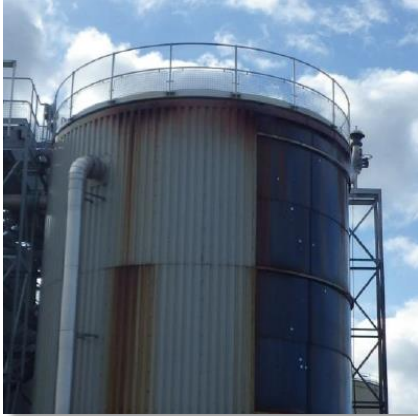
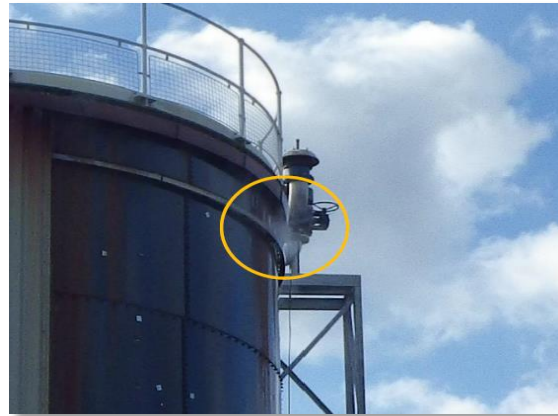
### February 2016 - Waste Water Treatment Works

Following reports of odour which could be detected over 3km away, the regulator inspected a permitted sewage sludge treatment centre and traced the source of the odour to a reactor tank which was visibly venting biogas from the top of the tank.

Sewage sludge inside the reactor tank is heated up to 55 degrees centigrade to kill off pathogens as part of the treatment process. The operator had already removed some of the insulation cladding, and based on the rust staining on the tank and on the remaining cladding, it appeared the tank had suffered from leaks at the point the lid of the tank meets the side walls.

Sewage sludge can be highly corrosive on steel tanks particularly at the point where the tank falls short of being full where liquid interfaces with the air/gas space inside the tank.

The tank had sustained some visible damage back in 2011 when it was over pressurised. Monitoring of the tank's condition since then was done by visual inspection alone and no informative structural survey was carried out to determine the future operational life of the tank. Cladded tanks can hinder the effective inspection of the tank walls themselves in spotting the early signs of corrosion occurring. Therefore, when installing cladded tanks consideration needs to be given to providing access to inspect the tank walls especially at the level of where a tank is normally filled to.

The odour problem was compounded by delays in sourcing and fitting specialist parts to enable the damaged tank to be fully isolated and bypassed.

The monitoring of the tank and whether it remained fit for continued use was not effective in ensuring that repairs were made or a replacement was installed before the tank started to vent biogas to atmosphere causing a significant and widespread odour problem.

- A drop off in biogas supply to Combined Heat & Power (CHP) plants or gas engines could be a strong indicator of biogas escaping from the system requiring immediate investigation and attention
- Retain critical and specialist parts in stock
- The tank was subsequently replaced with a new tank

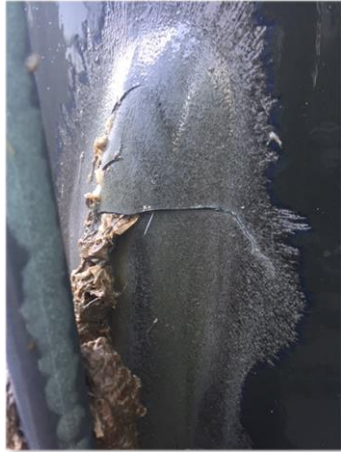
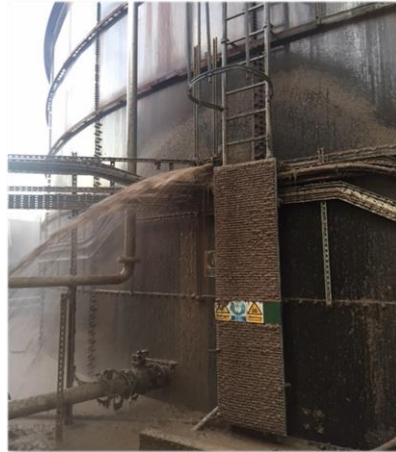
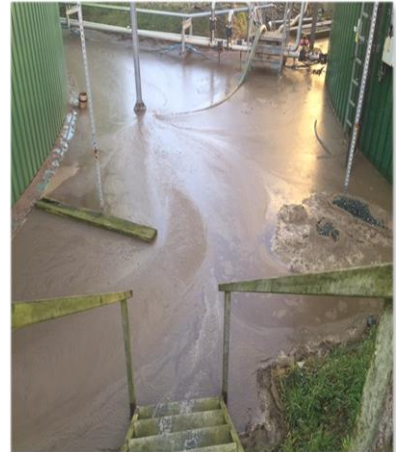
## November 2016 - Food Waste Plant

177 tonnes of raw processed food waste was lost into the contained area of an AD facility. No pollution to the environment occurred from the spilled digestate because of full containment being installed.

A submersible mixer within the tank had moved and damaged the tank due to incorrect installation. The mixing tank had recently been brought back into service following a tank refurbishment. There had been insufficient oversight of the process to re-commission the tank.

- Immediate emergency steps were taken to lower the tank contents to stop the leak. This involved utilising an adjacent tank which was empty and open awaiting refurbishment.
- The operator was able to access additional storage (alligator bags, tankers, empty clamp, hired in skips) to hold liquids. The ABP status meant these required disposal/further treatment.
- Consequences of flooding were reviewed and dome fans raised off the ground.
- Document review to address control of change and commissioning procedures.

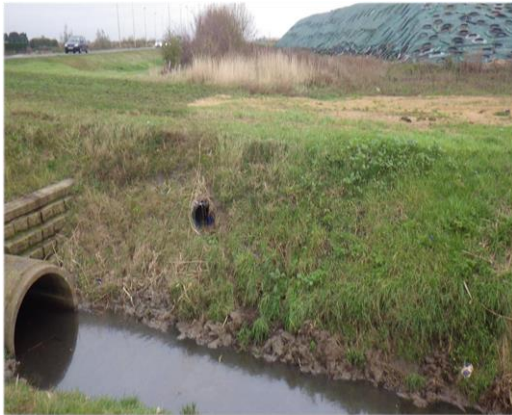
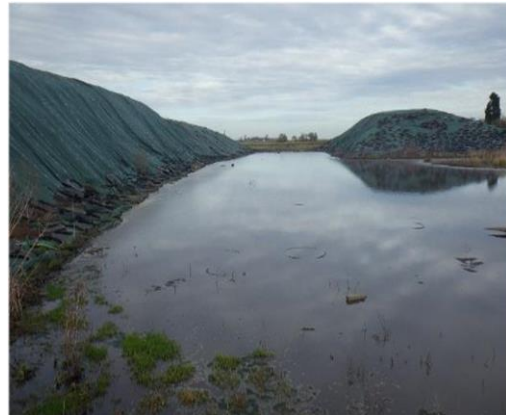
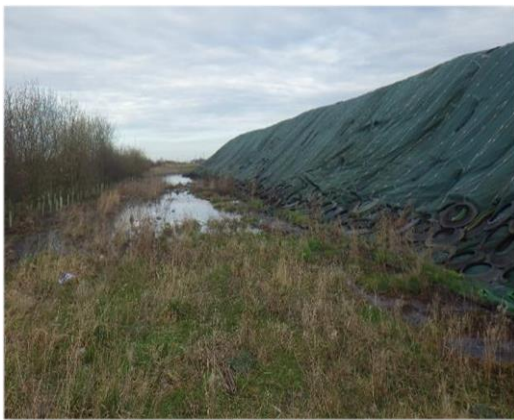
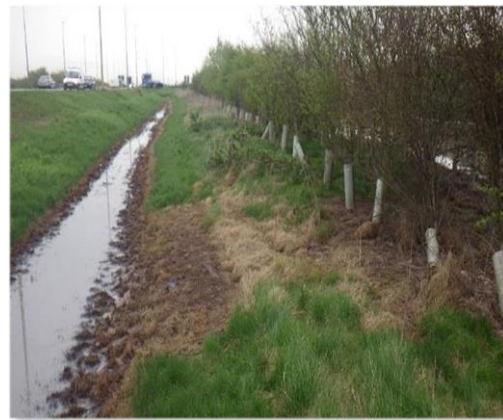
### November 2016 & March 2017 - Associated Storage Site

Environment Agency officers responded to reports of water pollution on 2 separate occasions. Large maize storage heaps produced significant quantities of silage effluent during winter which pooled in the field and entered a land drain, discharging directly into a nearby watercourse. On a second occasion silage effluent flowed over a bank into a roadside swale which connected to the same watercourse. Land drainage routes had been highlighted as a possible issue to the operator (land tenant) prior to storage.

The maize silage was stored for an excessive period of time due to the anticipated AD plant identified to receive the silage not being built. This led to a build-up of effluent and there was inadequate containment to manage it. The operator wasn't aware of any land drains, but they hadn't done proper checks for them at the storage location.

The field heaps were eventually moved by the farmer and advice was provided to him with regards to storage and land-drain assessment. For incident 1, the watercourse was bunded off and tankered out and the land drain was blocked off. For incident 2, the swales and pools of effluent by the heap were tankered out.

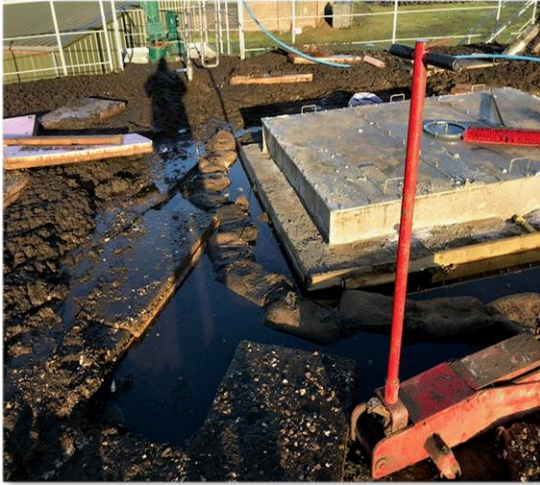
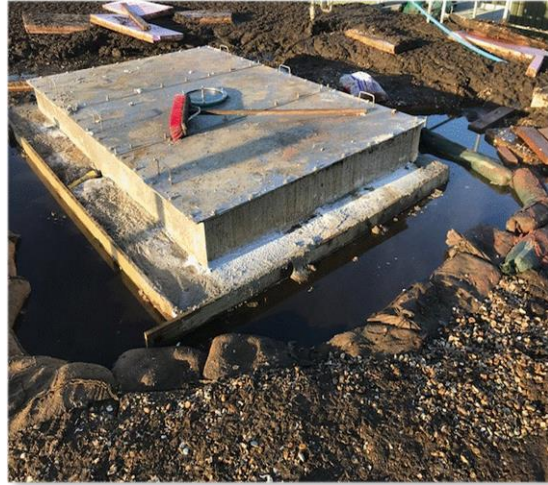
## December 2017 - Agricultural Installation

Following complete loss of power, a digester suffered an over-pressure event leading to the release of biogas and over-topping of digestate through the top hatch and relief valves. This was the second over-pressure event at the plant.

There was no uninterruptable power supply (UPS) for the router to enable remote access which meant off-site operators were unable to adequately assess the situation. Power to critical safety features such as the flare, dome inflation and process monitoring was not maintained because of failure of the back-up power generation system.

- The Power Failure procedure was re-written and made live on the system.
- The router for the site was connected to the UPS.
- 24 hour manning was put in place.
- The electrical import value was increased to 500 KW on a permanent basis meaning the generator and mains transformer would not need to work in parallel.
- Tank inspection undertaken.
- Digestate spill (contained on-site) was cleaned up.

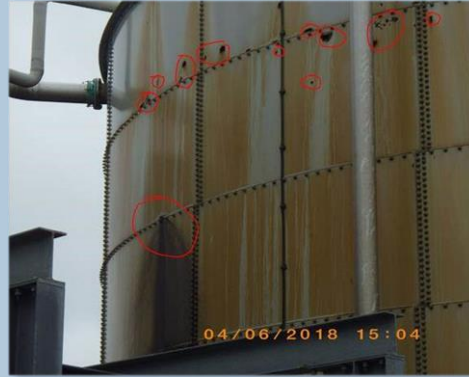
June 2018

Case study 1 - Large holes due to corrosion midway down a sludge tank resulting in a pollution incident and loss of storage capacity.

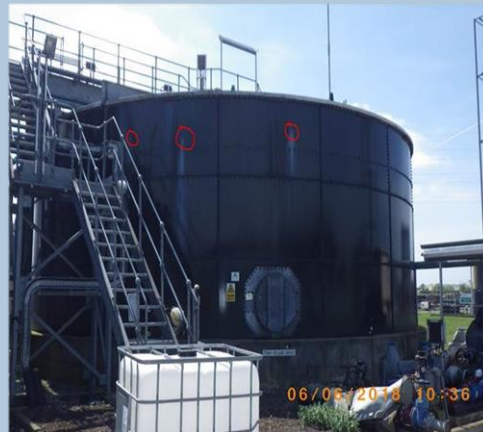
July 2018

Case study 2 - Holes appearing in pre-treatment and pre-thickened buffer tanks due to Hydrogen Sulphide corrosion. Ineffective maintenance programme that ensured tanks were repaired or replaced before visible holes occurred.

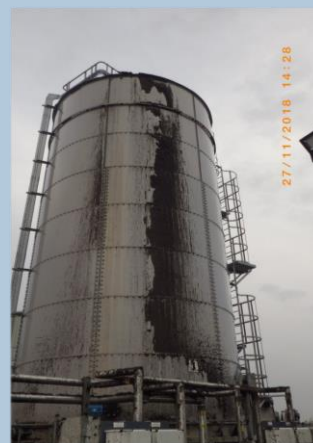
November 2018

Case study 3 - Failure in the automated process where a pump filling a cake reception silo did not cut out and continued to fill the silo resulting in loss of containment and odour pollution.

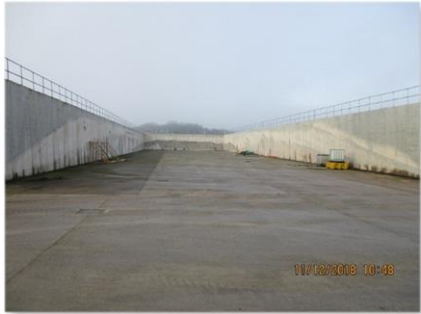
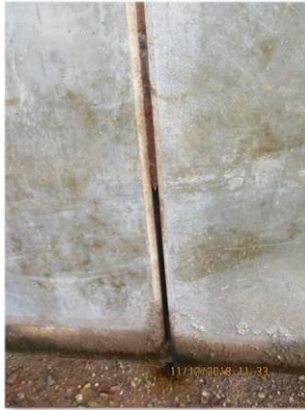
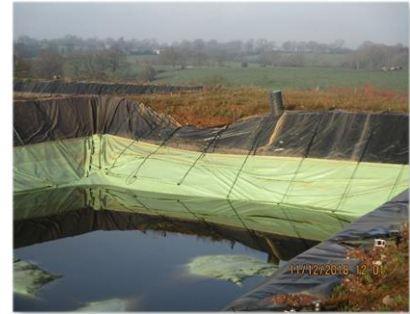
## April 2018 - Agricultural Plant

Significant loss of silage effluent to ground from numerous points on site including the silage clamps, site drains and lagoon. Scale of the loss was estimated to be approximately 500m<sup>3</sup>. Ammonia levels averaged ~50mg/l and BOD ~700mg/l.

Poor construction methods and CQA process. Poor management and inspection of plant and equipment.

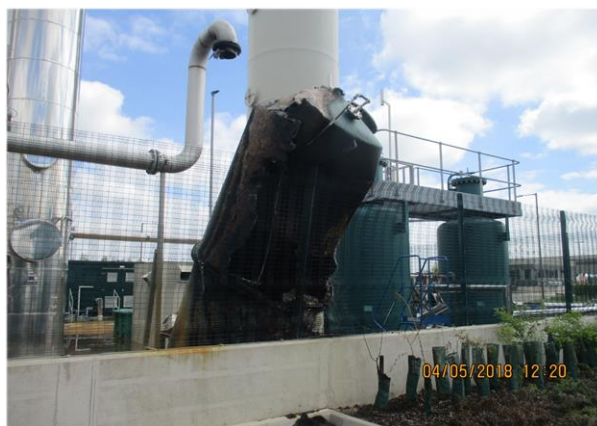
## April 2018 - Food Waste Installation

The AD plant has a biogas upgrading system for biomethane injection to the gas grid. The biomethane is separated from the rest of the gases in the biogas mixture by a water absorption system. The waste gases of mainly carbon dioxide, and low levels of hydrogen sulphide and VOC's are treated before emission to air.

Investigation into the cause of the fire concluded that the most likely cause was the formation of pyrophoric iron sulphide within the CIF. This can form if there is not enough oxygen to react with the iron sulphide.

The system had a constant air flow into the unit and it was not possible to block or bypass this as it would automatically shut the gas upgrading system. Also the media had to be water washed daily to remove sulphur build up and expose the media surface. This was completed automatically on a wash cycle. The system was operated in accordance with the manufacturers recommendations and the fire was thought to be an exceptional event.

Improvements to the system were identified after the incident. The CIF was replaced with two large ferrosorp units as these presented a reduced fire risk. Temperature monitoring and a firewater system was installed and additional in-line H<sub>2</sub>S monitoring put in between each stage.

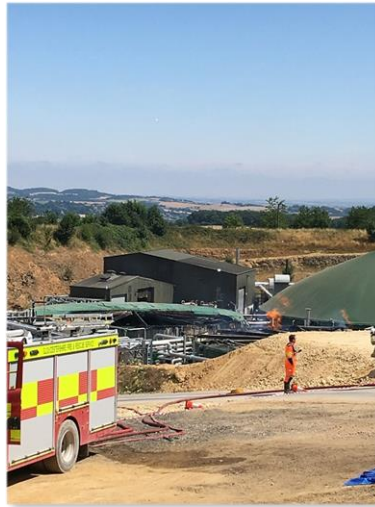
## July 2018 - Food Waste Plant

A fire engulfed a control room and spread to nearby mixing and digester tanks and their associated pipework. Biogas holders above the tanks were completely destroyed by the fire and the biogas burned off to atmosphere. Damage was also caused to pipework and the concrete walls of the two affected tanks but they did not collapse and no digestate was lost.

- New concrete bund to provide secondary containment for all digestate tanks built to CIRIA c736 standard. (Gas engines kept outside the bund)
- All 'legacy' plastic pipework and fittings (only small number of these) replaced.
- Affected tanks replaced with new concrete tanks.
- CQA of existing tanks in place providing confidence in construction materials & methods
- Cladding on all tanks replaced with an alternative material with higher level of fire resistance.
- Additional gas alarms were installed on site.
- Revised Fire Response Plan (avoiding use of cold water on hot concrete)
- Improved liaison with the Fire & Rescue Service in AD matters.

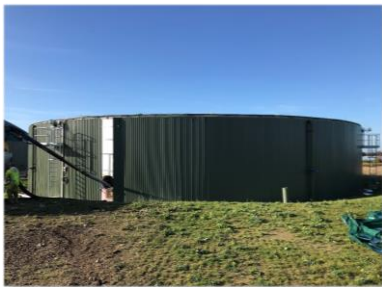
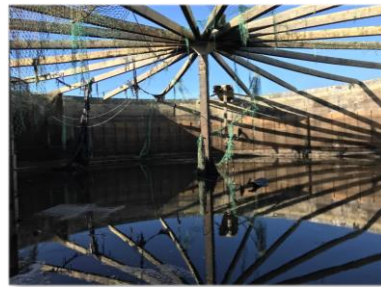
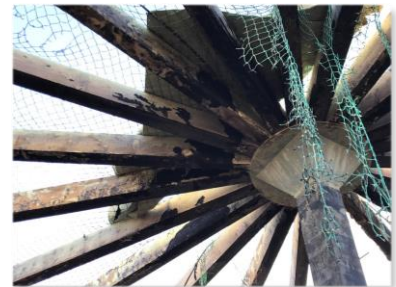
## October 2018 - Agricultural Facility (Non-regulated)

A lightning strike hit a digestate storage tank resulting in a fire which destroyed the inner and outer roof membranes. The strike hit at 01:30am so the site was unmanned at the time. The Fire Service attended and SCADA alarms alerted the operator. The tank had been mostly drained (~1m depth) of its digestate beforehand due to planned maintenance the following day. The gas supply had already been isolated from the rest of the tanks and gas was not being drawn from it. Minimal biogas lost to atmosphere and minimal environmental impact as a result however process downtime and costs associated with replacing the roof.
